Journal section: *Biomaterials and Bioengineering in Dentistry*
Publication Types: *Research*

Influence of low concentration acid treatment on lithium disilicate core/veneer ceramic bond strength

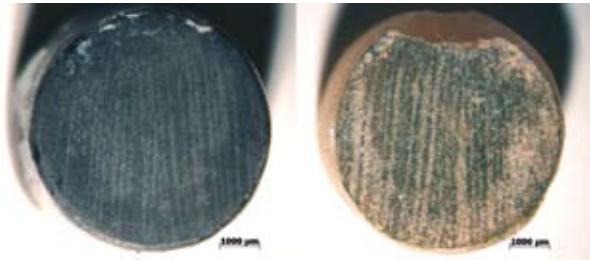
Fig. 1. Representative image of fracture for the control group (CoCr) visualized in optical microscopy. Infrastructure portion is on the left and veneering porcelain portion is on the right. Observe the oxide layer adhered to the porcelain.

Distinct failures among the groups were found. The control group (CoCr) showed predominantly adhesive failures and the fragments of veneering porcelain took away the oxide layer, suggesting adhesive failure between the oxide layer and the metal. The groups LD-treated and LD-untreated presented predominantly cohesive failure in the infrastructure. Representative images of the fractures can be observed below (Fig. 1,2). The failure modes can be visualized on Table 4.

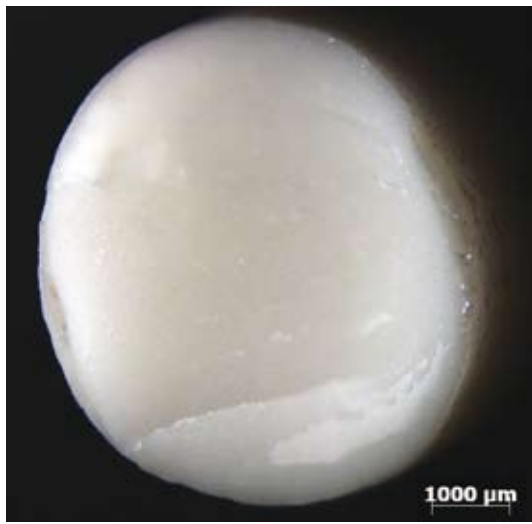
Fig. 2. Representative image of the predominantly cohesive fracture of the infrastructure for the lithium disilicate (LD) groups visualized under optical microscopy.

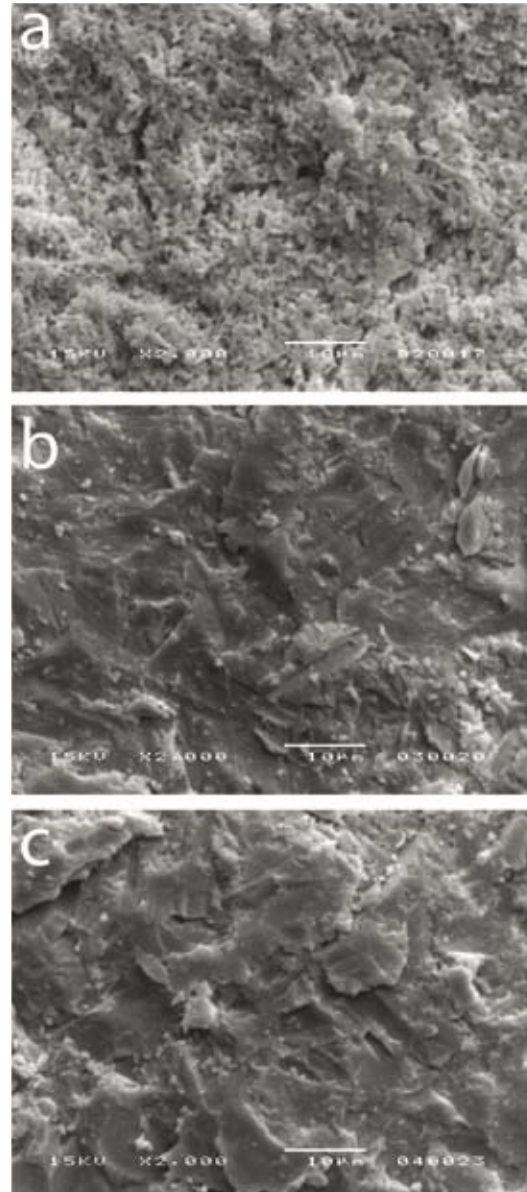
Fig. 3. A-Lithium disilicate surface of after treatment with 10% hydrofluoric acid during 20 seconds; B- Lithium disilicate surface after treatment with low concentration acid solution during 20 minutes; C- Lithium disilicate surface without treatment.

The lithium disilicate surfaces were analyzed after different treatments. On the 2000x magnifying it was observed that, when the 10% hydrofluoric acid was applied during 20 seconds, there was the dissolution of the glassy phase, exposing the lithium disilicate crystals (Fig. 3). When the acid solution composed by approximately 0.6% hydrofluoric acid and 1.7% sulfuric acid was applied, the image was very similar with the absence of treatment, indicating that this solution was ineffective to modify surface morphology (Fig. 3).

Lithium disilicate is an acid sensitive material. The acid treatment with 10% hydrofluoric acid causes morphological changes in the surface, as observed on Fig. 3, and is responsible for an improvement of the micro-mechanical retention of the materials such as resinous cements (7). However, the Scanning Electron Microscopy (SEM) images obtained during this study, showed that the treatment with acid solution composed by 0.6% hydrofluoric acid and 1.7% sulfuric acid did not provided significant morphological differences in the surface of the material (Fig 3) when compared to no treatment at

all (Fig. 3), which suggests, combined with shear bond strength data, that it is not essential to achieve good bonding between the materials.
