The Effect of surface topographical changes of two different surface treatments rotary instrument

Qaed NA, Mourshed BD, Al-Shamiri HM, Alaizari N, Alhamdah SS.
The Effect of surface topographical changes of two different surface treatments rotary instrument. J Clin Exp Dent. 2018;10(1):e49-53.
<http://www.medicinaoral.com/odo/volumenes/v10i1/jcedv10i1p49.pdf>

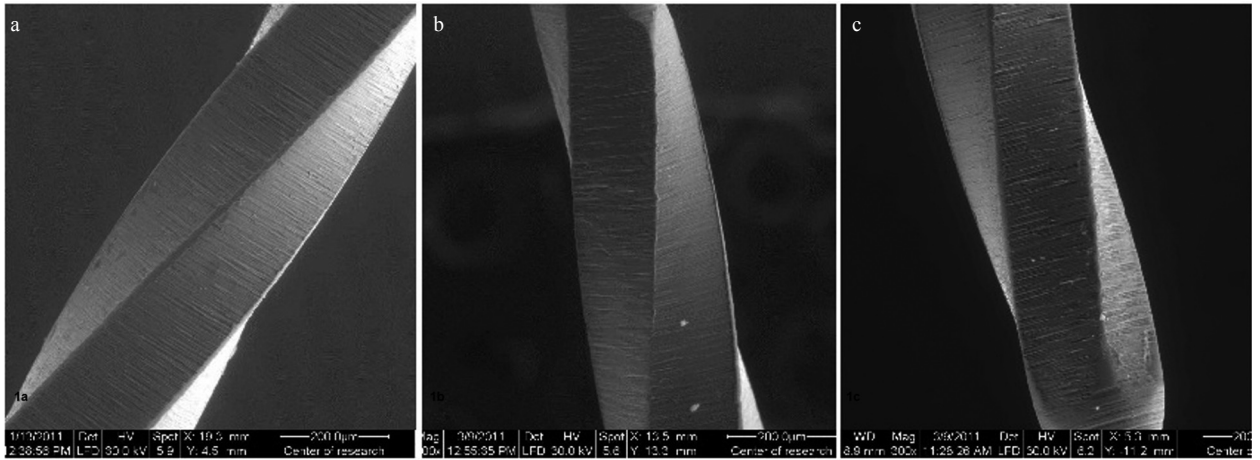
Fig. 1: (a): Scanning electron micrograph of unused AlphaKite file (subgroup A1) with marked machining grooves (X300-Magnification) (b): Scanning electron micrograph of AlphaKite file after (subgroup A2) presenting disruption and blunting of cutting edges and deepening of the machining groove (X300 magnification) (c): Scanning electron micrograph of AlphaKite file (subgroup A3) showing microcracks (white arrow) and deepening of the the machining grooves with metal stripping along the cutting edge (black arrow) (X300 magnification).

On examining the AlphaKite files subgroup A1, the unused group, under ESEM, revealed gross machining grooves on their surface with no pits, strips or disruption (Fig. 1a).

After three uses and one autoclave cycle, subgroup A2, scanning electron micrographs showed disruption of cutting edges that were also blunted and scraped with deepening of the machining grooves (Fig. 1b).

After nine uses and three sterilization cycles in autoclave, subgroup A3, the scanning electron micrographs showed microcracks and deepening of the machining grooves with metal stripping along the cutting edge (Fig. 1c). In this group also one of the instruments was fractured. The fractured surface under magnification (X 205) showed the classical signs of ductile fracture; plastic deformation with areas showing irregular dimples and concentric abrasion marks at the periphery with a fibrous appearance in the center (Fig. 2a).

Both AlphaKite and Rivo S NiTi files showed changes their cutting edges after 3 uses and one autoclave cycle. As shown in Fig. 1b AlphaKite files under the scanning

electron micrographs showed disruption of cutting edges that were blunted and scraped with deepening of the machining grooves while Revo-S files, the dulling and blunting of the cutting edges was predominant (Fig. 2c).

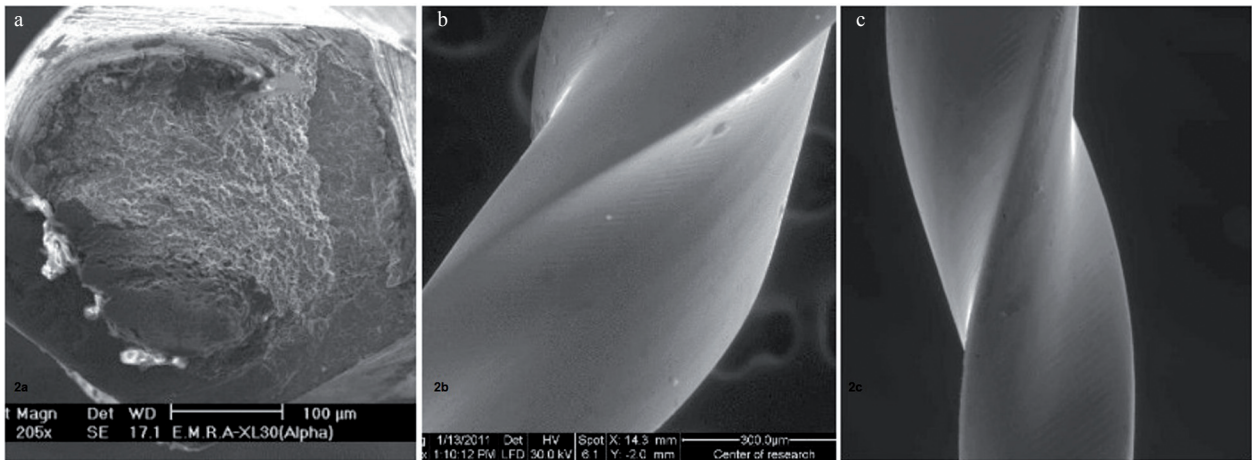
Fig. 2: (a): Scanning electron micrograph of AlphaKite file (subgroup A3) showing macroscopic plastic deformation at the fracture site (black arrow). Signs of ductile fracture, and irregular dimples that resembles a fibrous structure (white arrow) (X205 magnification) (b): Scanning electron micrograph of unused Revo-S file (subgroup B1) with smooth surface and slight machining groove (X300 Magnification) (c): Scanning electron micrograph of Revo-S file (subgroup B2) showing dulling and scrapping of the cutting edges (X300 magnification).

By examining Revo-S files, the scanning electron micrographs of unused files, subgroup B1, showed a smoother surface with few machining grooves (Fig. 2b).

On examining Revo-S files after three uses and one sterilization cycle, subgroup B2, dulling and blunting of the cutting edges was predominant (Fig. 2c).

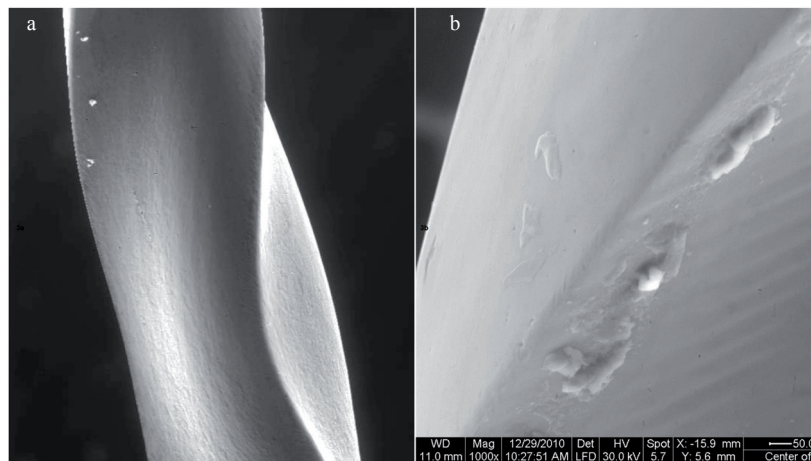
Fig. 3: (a): Scanning electron micrograph of Revo-S file (subgroup B3) showing unwinding (x200 magnification) (b): Scanning electron micrograph of Revo-S file (subgroup B3) showing metal flakes on the file surface (X1000 magnification).

After nine uses and three sterilization cycles, subgroup B3, files showed plastic deformation in the form of unwinding of the flutes, disruption in the surface with metal flakes (Fig. 3a,b).
