Journal section: Operative Dentistry and Endodontics
 Publication Types: Research

Fracture and deformation of ProTaper Next instruments after clinical use

Background: The aim of this study was to evaluate the fracture and defects observed in ProTaper Next files discarded after a normal clinical use.

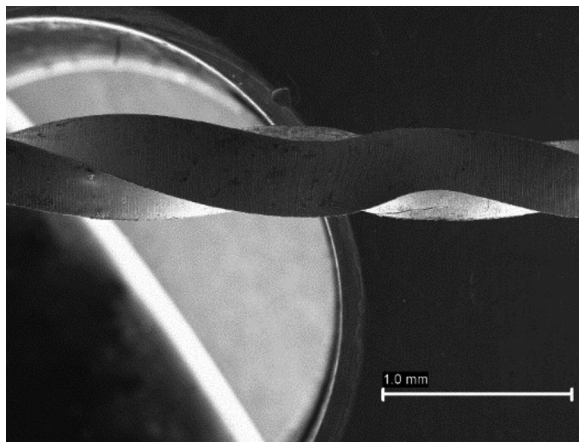
Unwinding (Fig. 1) was also observed mainly in the 17.04 file (17 files, 10.56%), like the presence of cur-

Fig. 1: Images captured by stereomicroscope. Unwinding file.

ving or bending (2 files, 1.24%). This caused the file X1 presented the highest rate of defects (31.67%) followed by the file X2 (10.69%). It is important to note that the X4 and X5 files did not show any type of defect. On the other hand, a z test was realized to check the difference between visible and non-visible defects, and the defects are significantly different ($p < 0.01$).
