Journal section: *Prosthetic Dentistry*Publication Types: *Research*

Shear bond strength of debonded ceramic restorations re-cemented by means of a cleaning and retreatment protocol

Abstract

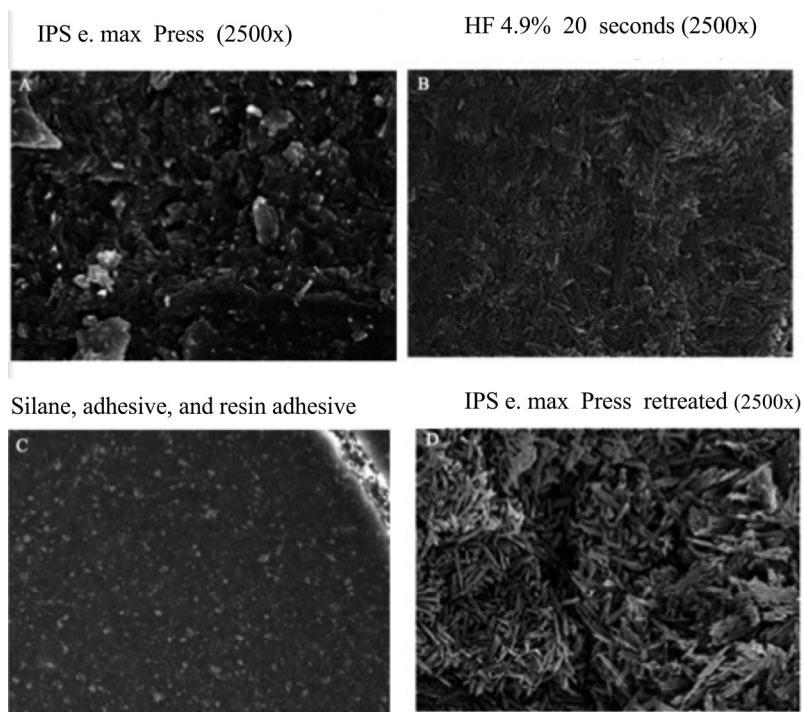
Fig. 1: Electronic microscope images of lithium disilicate ceramic surface (A). Change produced by acid etching (B). Ceramic surface after silanizing and applying resin adhesive (C). Surface almost identical to image B after decontaming surfaces using proposed protocol (D).

In 2015, a protocol was proposed for carrying out decontamination of the ceramic restoration of all resin adhesive remnants, monitoring the technique under electronic microscopy (11) (Fig. 1). Having corroborated

processes. Scanning electron microscope (SEM) images (Fig. 1) show that after applying thermal treatment to the debonded restoration, the surface is left clean and retentive (11).

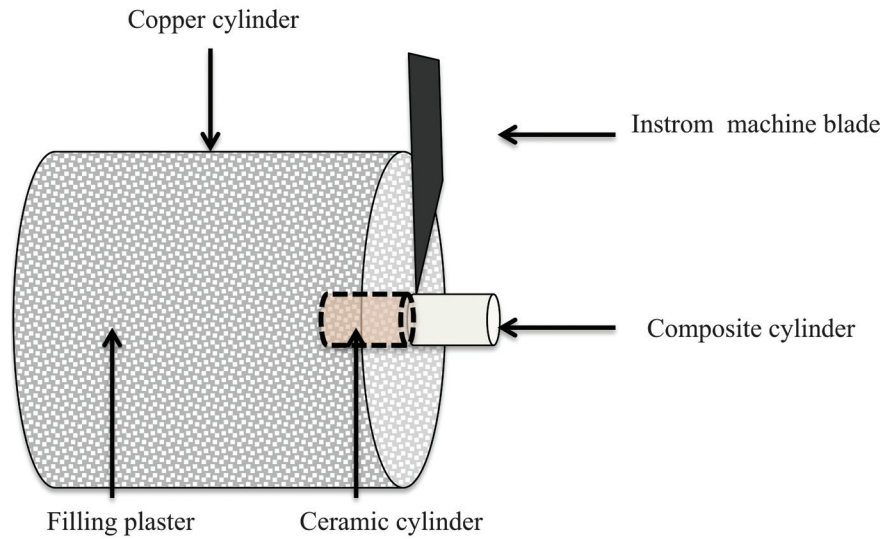
Fig. 3: Illustration of sample set in copper cylinder for shear bond testing.

AG-X plus universal test machine (Shimadzu Corporation, Kyoto, Japan) with 1000 N load cell. All samples were set in copper cylinders using Type IV plaster. The cylinders were positioned firmly and horizontally in the test machine (Fig. 3). The machine applied force to the composite cylinder until the moment when fracture of the cement-restoration ensemble was produced.

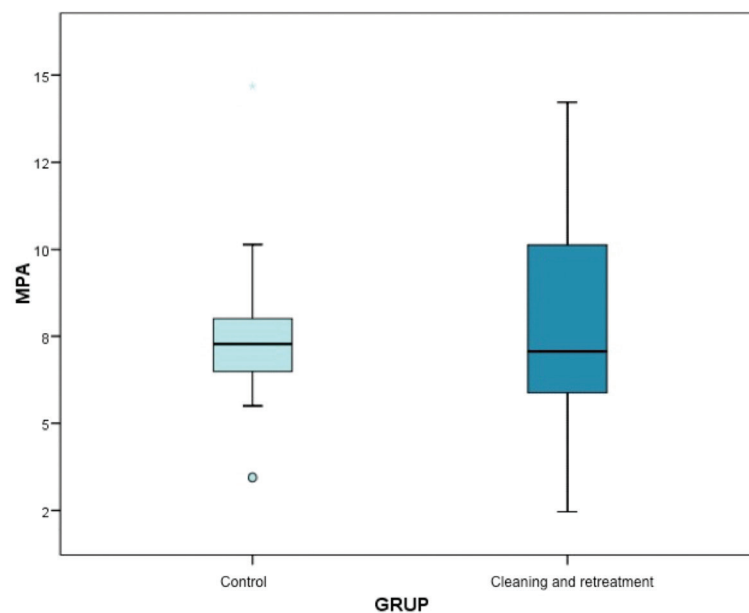
Fig. 4: Blox-Pot representing data distribution and median values obtained.

The descriptive statistics calculated were very similar for both groups. The box-plot in Figure 4 represents

these data showing the distribution of values obtained. The median force in both groups is situated at almost the same level. Nevertheless, the greater variability in Group 2 is due to the disparate results obtained by two individual samples. The Mann Whitney test confirmed that there was sufficient statistical evidence to conclude that shear bond strength was similar between groups, without statistically significant difference ($p=0.983$), (Table 2).
