## Fracture strength and ribbond fibers: *In vitro* analysis of mod restorations

Zotti F, Hu J, Zangani A, Albanese M, Paganelli C. Fracture strength and ribbond fibers: *In vitro* analysis of mod restorations. J Clin Exp Dent. 2023;15(4):e318-23.

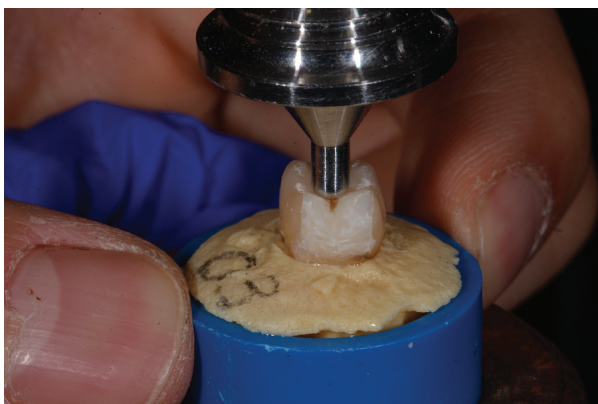
The specimens were placed in PVC boxes with a diameter of 20 mm and a height of 20 mm at the CEJ (cement-enamel junction) using a self-curing acrylic resin (SR Ivolen Kit - Ivoclar Vivadent, Liechtenstein). The boxes were placed on the platform of the 2000-N load cell Instron Machine (Instron 5848, Norwood, Massachusetts USA) to test the fracture strength under vertical axial loads. To achieve closer contact between the fossa-cusps and the Instron tip, a special insert for the machine with a spherical tip of 3 mm was designed and custom made (Fig. 1).

Fig. 1: Custom made insert for Instron.

In order to proceed with the experimental part of this study, it was necessary to develop a special insert to perform the tests using the Instron (Instron 5848, Norwood, Massachusetts USA). This was necessary because the preliminary tests with test specimens did not give satisfactory results because the inserts supplied by the manufacturer were not able to break the tooth elements except at forces above the normal masticatory load. We assumed that this was due to the shape of the insert used in the tests, which was not able to contact the masticatory fossa and come into close contact with the cusps, which is inevitable in a functional masticatory process. In fact, the insert provided had a smooth, circular surface with a diameter of 1.5 cm, which did not allow optimal contact with the cusps and pits of the teeth. In the literature, inserts with a spherical surface and a much smaller diameter on the order of 5 mm are commonly used. In literature studies by King and colleagues (12-14), a fracture strength of 2500 to 3500 N was found in healthy

mandibular molars using a spherical insert with a diameter of 5.6 mm. In their study, Watts and colleagues (13) investigated fracture resistance using two spherical inserts with different diameters, one 4 mm and one 8 mm. With the 4-mm spherical insert, they determined a fracture toughness of 2740 N, while with the 8-mm insert, they found a fracture toughness of approximately 4000 N. From this, they concluded in their study that the difference in strength is directly related to the diameter of the insert used; the larger the diameter, the higher the value of fracture toughness. This is consistent with the observations from tests conducted prior to our actual experiments. Therefore, in the absence of a suitable insert for the planned tests, it was decided to design and have manufactured a special spherical insert with a diameter of 3 mm for the Instron (Instron 5848, Norwood, Massachusetts, USA), which proved to be the most suitable size to obtain maximum contact with the cusps and pits of the specimens.

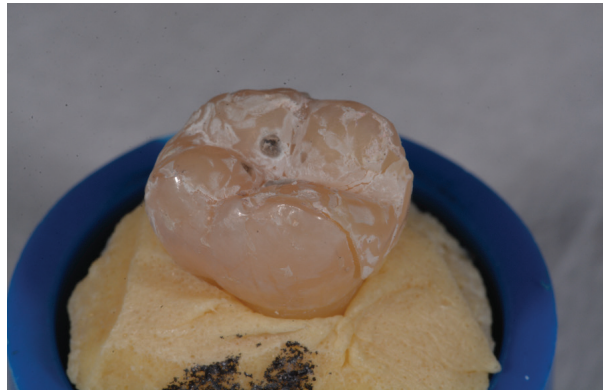
- 1) Fracture of the composite resin (Fig. 2)
- 2) Fracture of one or more cusps (Fig. 3)
- 3) Fracture extending to the CEJ or deeper (Fig. 4)

Fig. 2: Fracture of the composite resin.

In G1 the 80% of fractures detected was found to be restorable by a conservative intervention, the same for the G2 in which 80% of the samples was restorable and the fractures detected were visible just in the thickness of the composite resin.

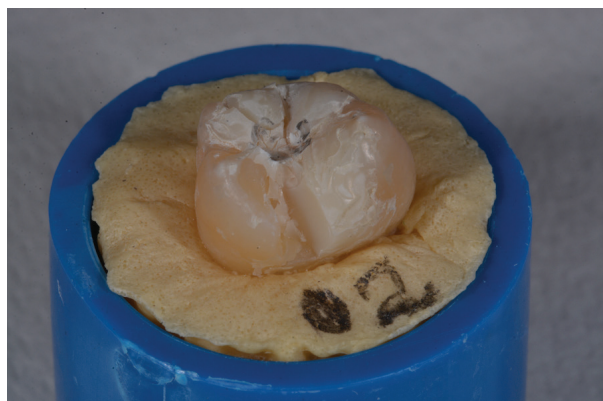
Fig. 3: Fracture of one or more cusps.

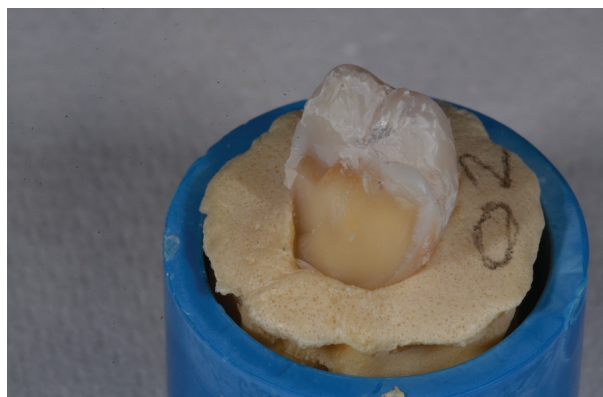
Fig. 4: Fracture extending to the CEJ or deeper.

The literature indicates that fractures rarely occur along the CEJ (15,16) because it is an interface that can act as a shield for the propagation of fracture edges. Therefore, the CEJ should be preserved as much as possible during cavity preparation. According to Bechtle and colleagues (16), fracture arrest occurs only when microcracks reach the CEJ starting from the enamel part of the tooth. If the fracture originates from the dentin part, the tooth may fracture completely after a certain amount of plastic and elastic deformation.
